Final Report

Effect of Damage Processes on Spallation Life in Thermal Barrier Coatings

(AFOSR Grant # F49620-98-1-0390 ; Program Monitor – Dr. H. Thomas Hahn)

Golam Newaz (PI)

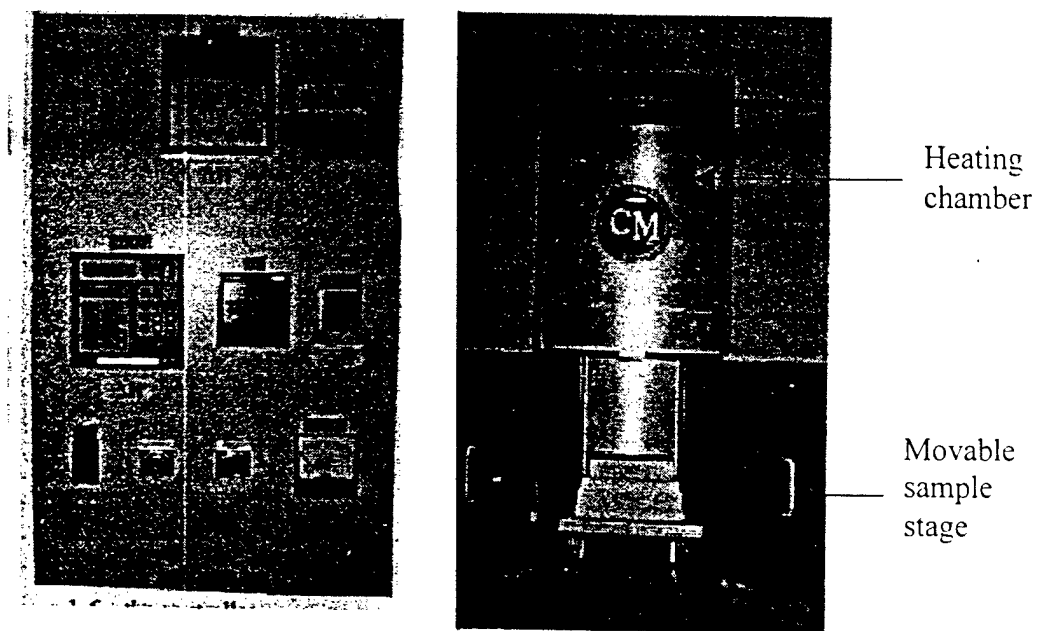
Figure 2.4 shows photograph of CM 1610 BL system for thermal cyclic test. (a) controller; (b) furnace.

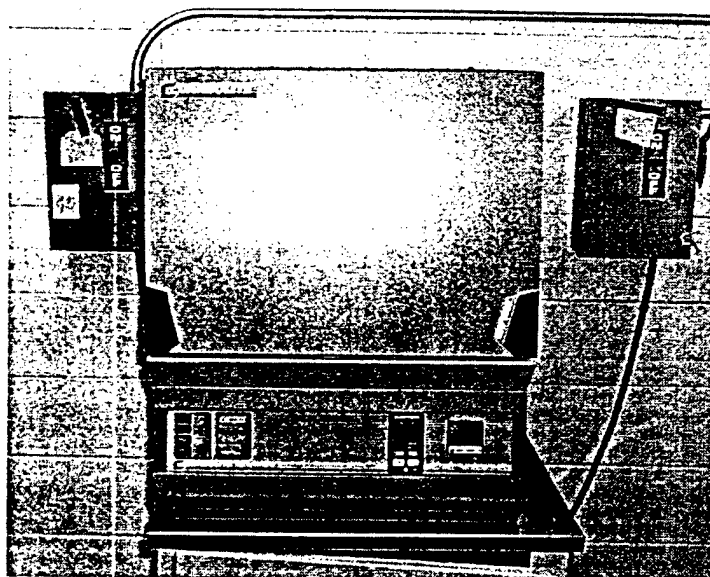
Figure 2.5 shows CARALITE RHF 1400 furnace for isothermal test.

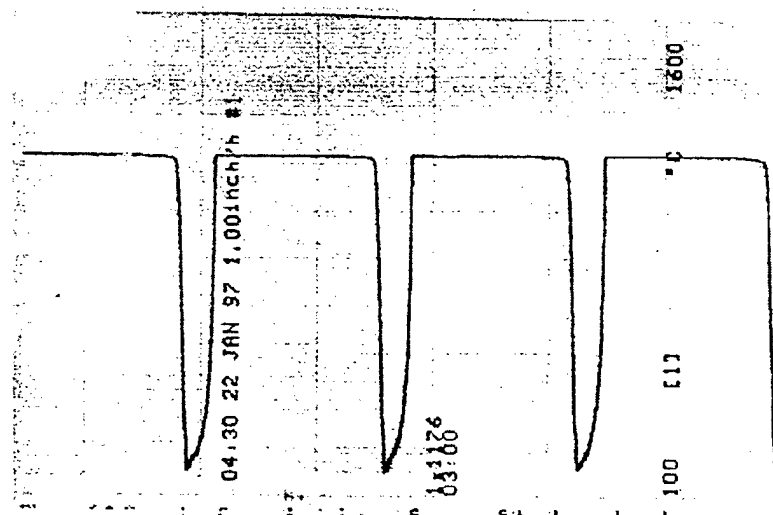
Figure 2.6 shows a sample of recorder print out for one of the thermal cycles.

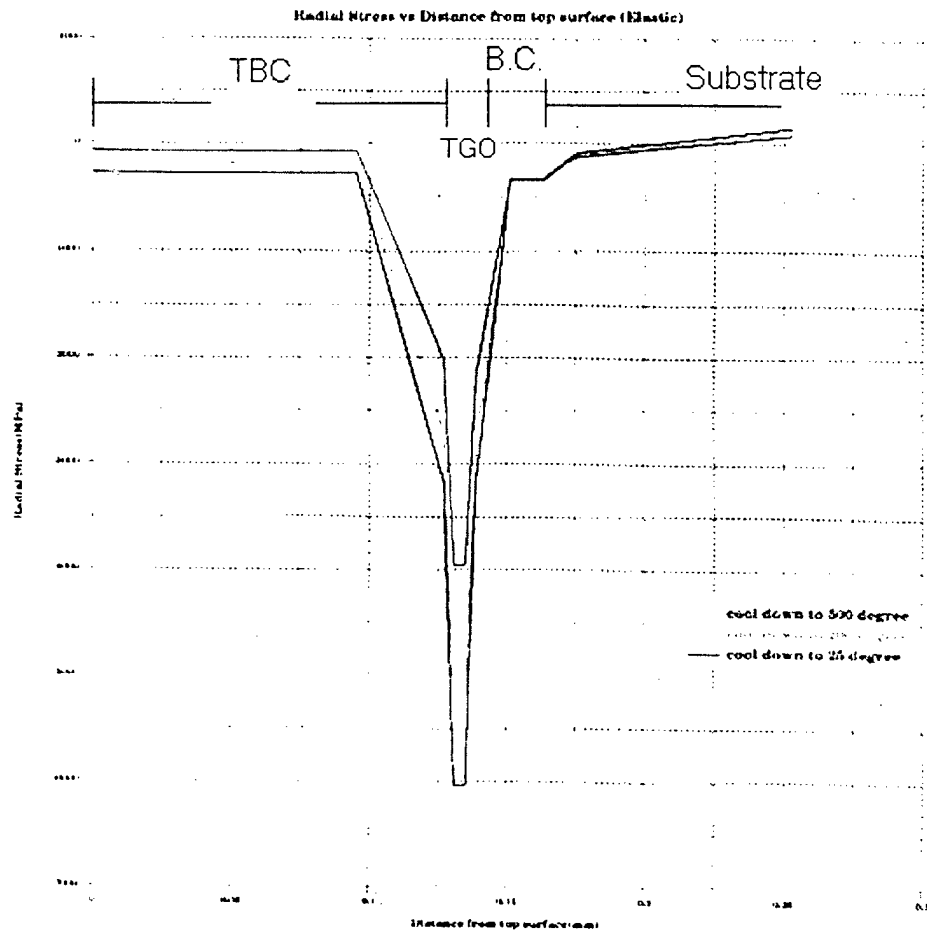
Figure 3.3 shows residual radial stresses at all layers in TBC system at temperature dropping from 1177 °C to 500 °C, 200 °C and 25 °C, Using elastic FEA modeling.

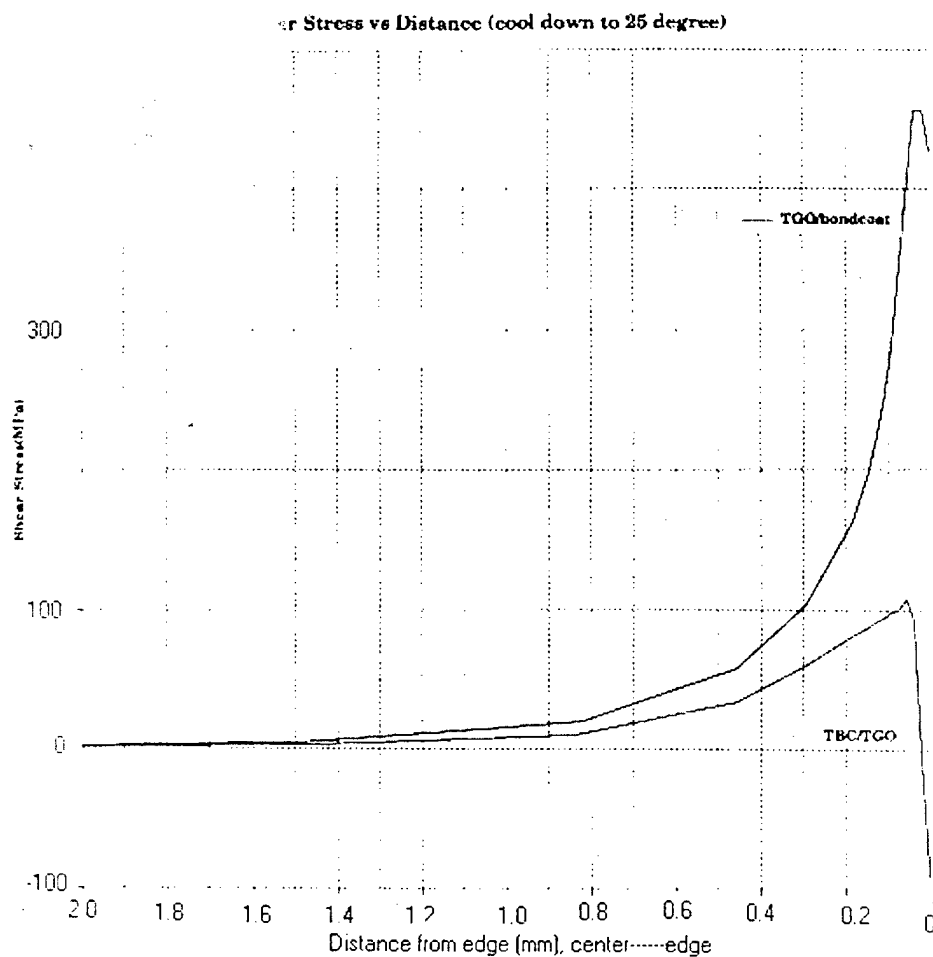
Figure 3.5 shows shear stress distribution along TBC/TGO and TGO/bond coat interfaces at edge area of a specimen cooling from 1177 °C to 25 °C.

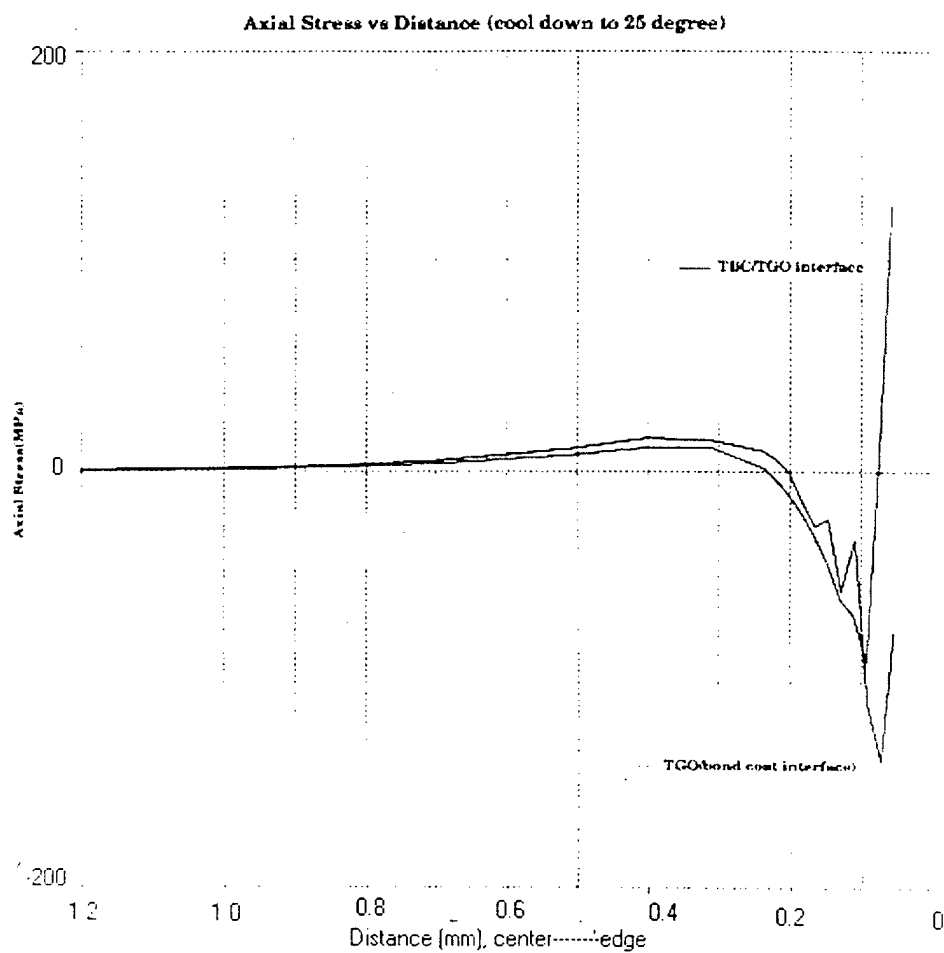
Figure 3.6 shows normal out-of-plane stress distribution along TBC/TGO and TGO/bond coat interfaces at edge area of a specimen cooling from 1177 °C to 25 °C.

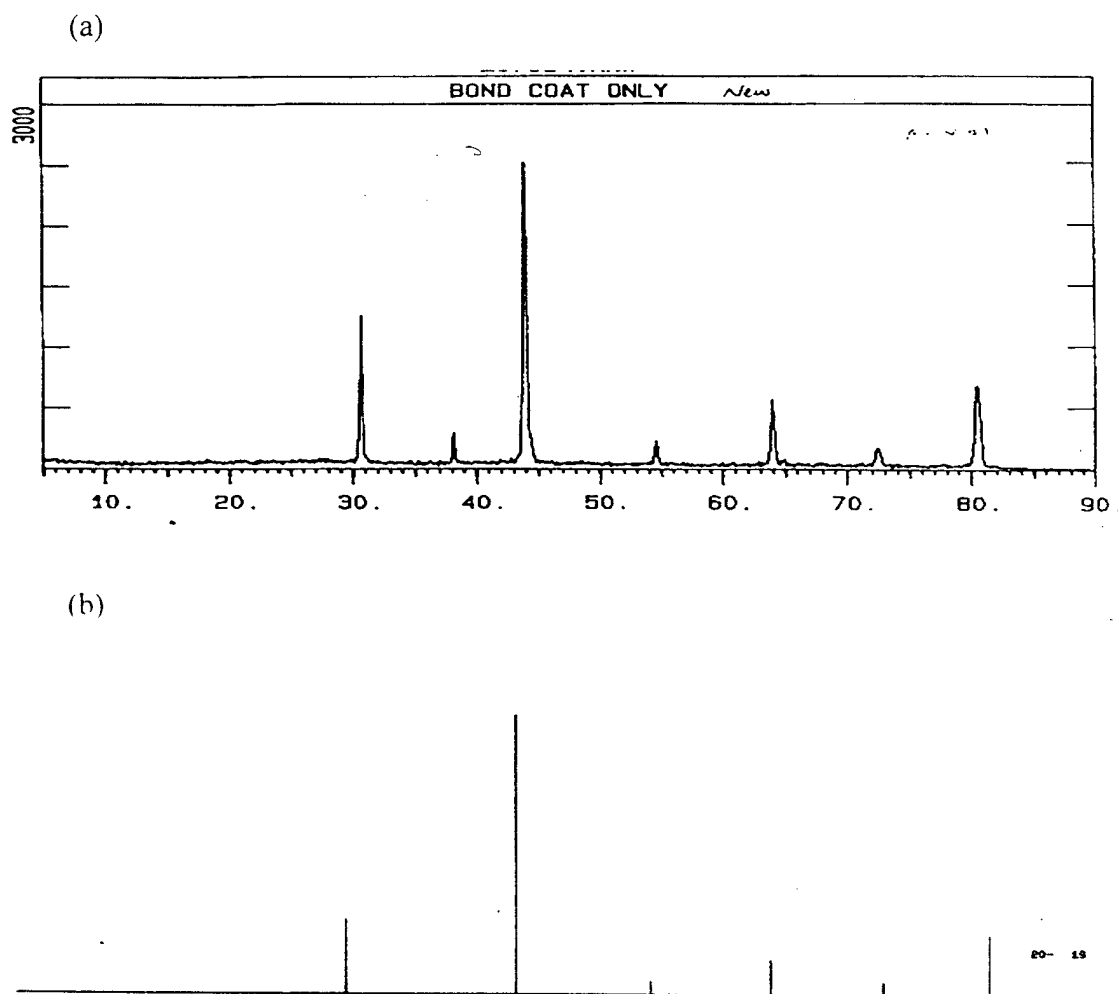
Figure 4.2 is x-ray diffraction pattern derived from the bond coat surface as-received condition (a). (b) is a standard pattern of β -NiAl phase (reference card number is 20-19).

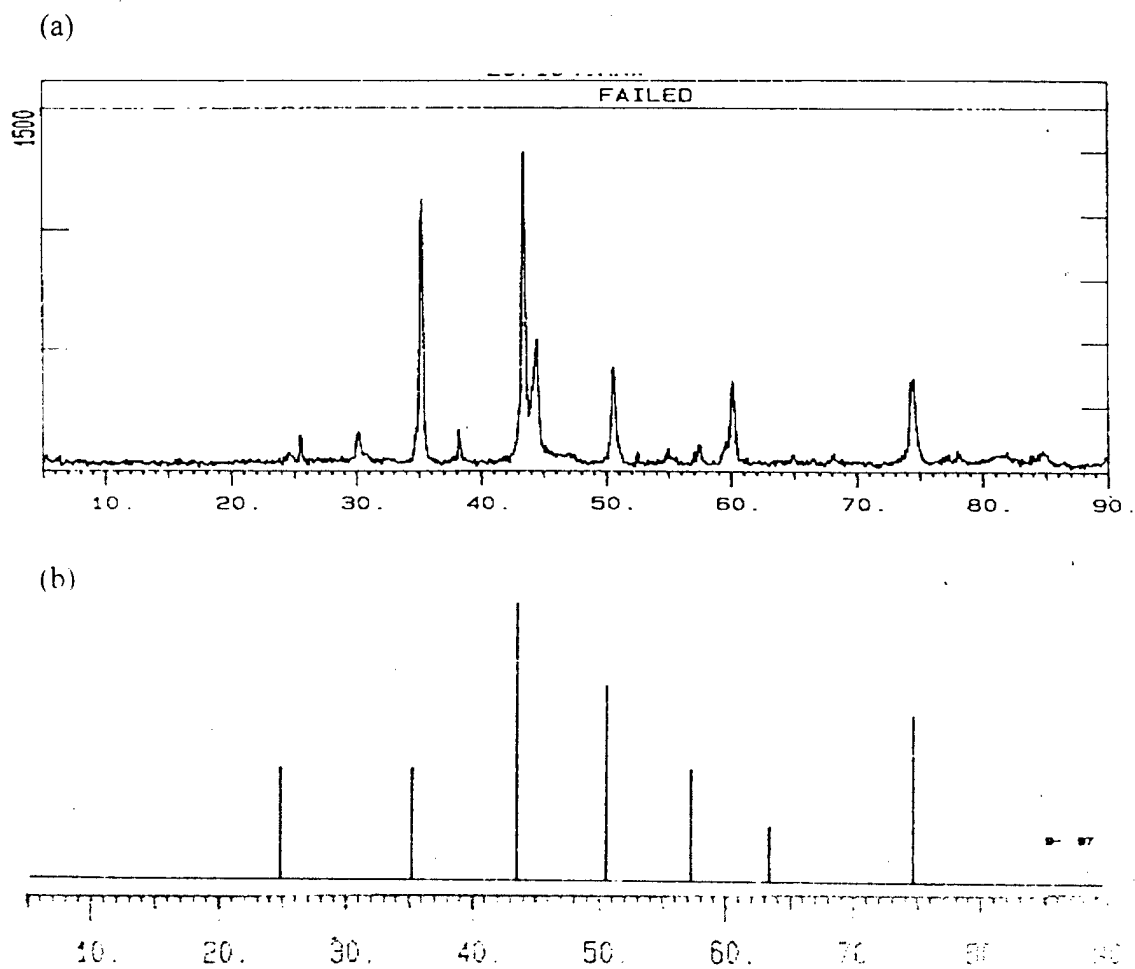
Figure 4.5 is x-ray diffraction pattern derived from the bond coat surface after TBC and TGO were removed at 180 cycles of thermal test B (a). (b) is standard pattern of γ' -Ni₃Al phase (reference card number is 9-97).

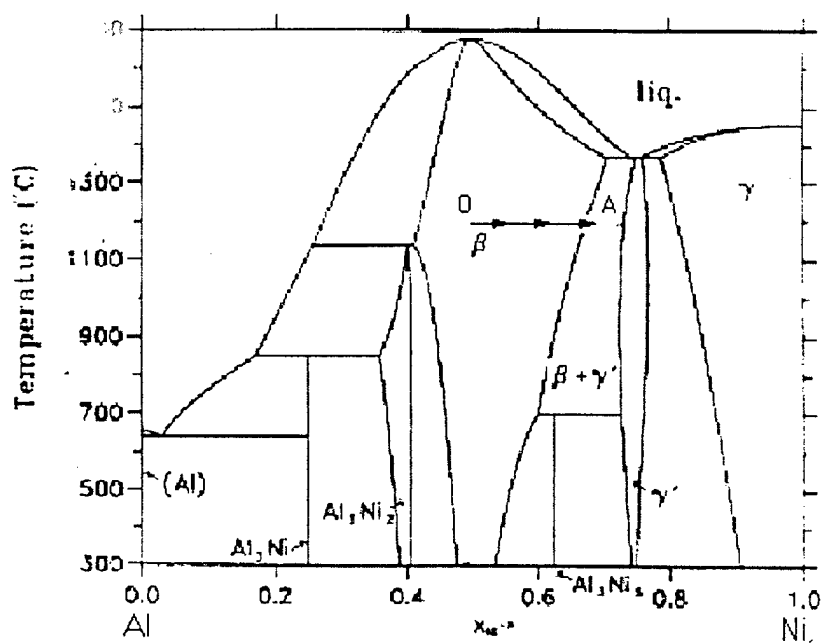
Figure 4.6 is Ni-Al system phase diagram. Composition of bond coat changed along $O \rightarrow A$ path during thermal cycling at thermal test B.

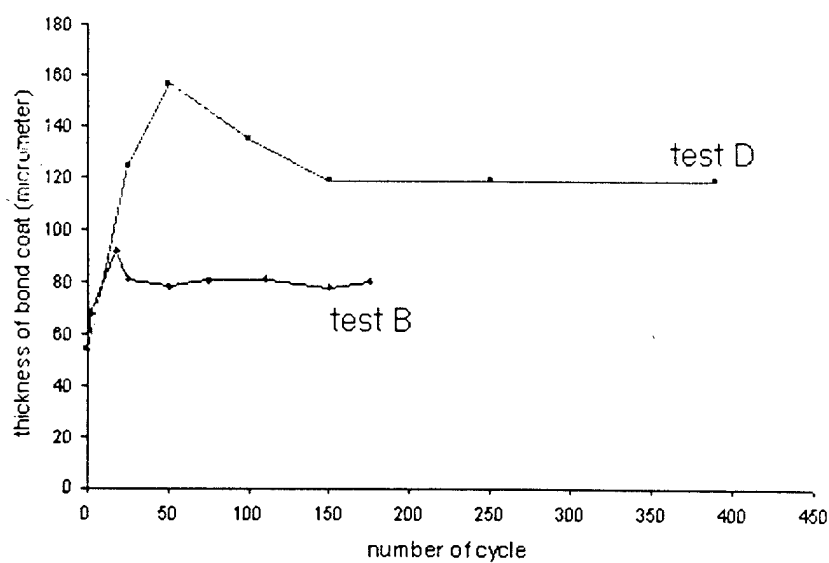
Figure 4.7 shows thickness of bond coat layer changed with increased thermal cycling at thermal test B and D.

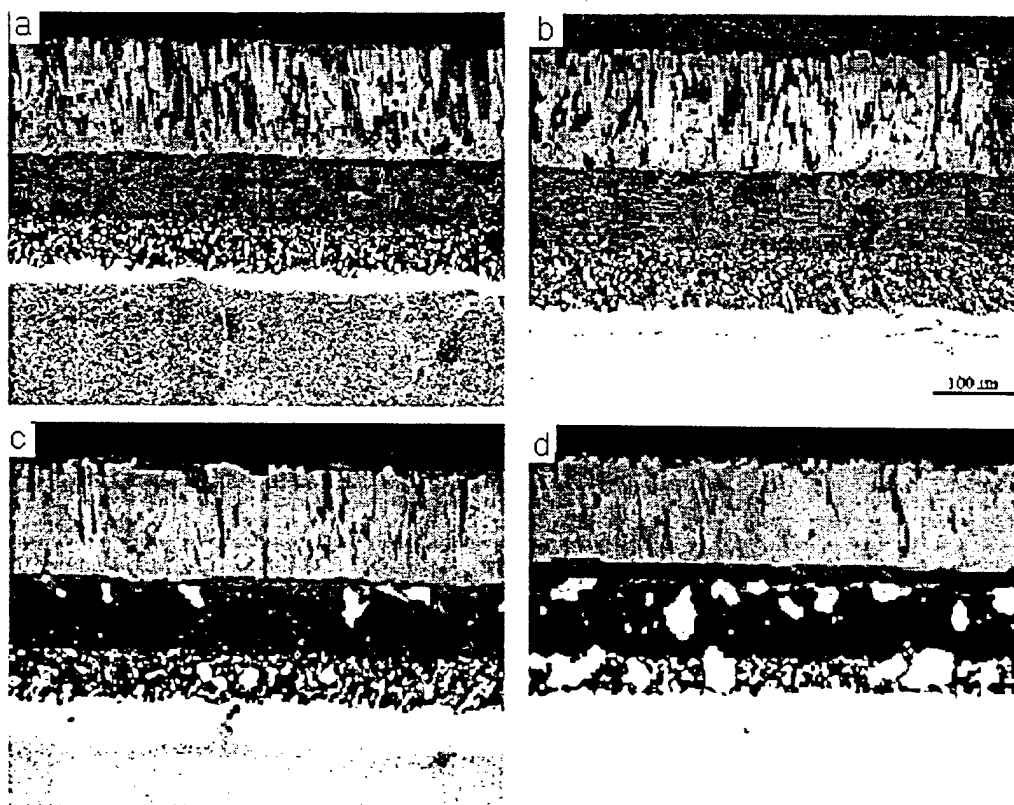
Figure 4.8 shows the microstructure evolves with thermal cycling at thermal test D (a) 25 cycles, (b) 50 cycles, (c) 100 cycles (d) 390 cycles.

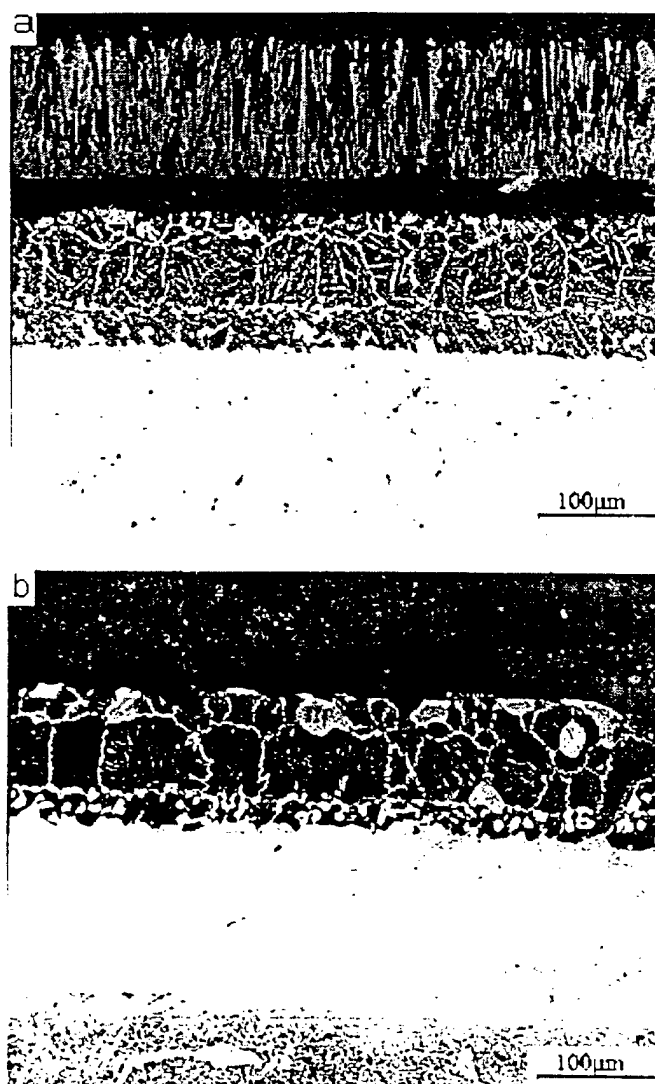
Figure 4.9 shows microstructure of bond coat at isothermal test. (a) 80 hours. (b) 150 hours at which the TBC spalled off.

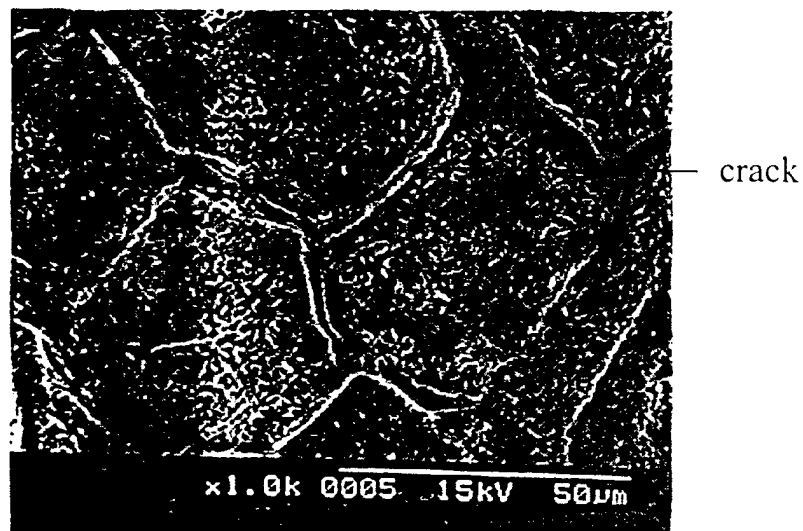
Figure 5.2(a) shows the top surface of type 2 specimen after 25 B cycles. Cracks formed at the impression of bond coat grain boundary.

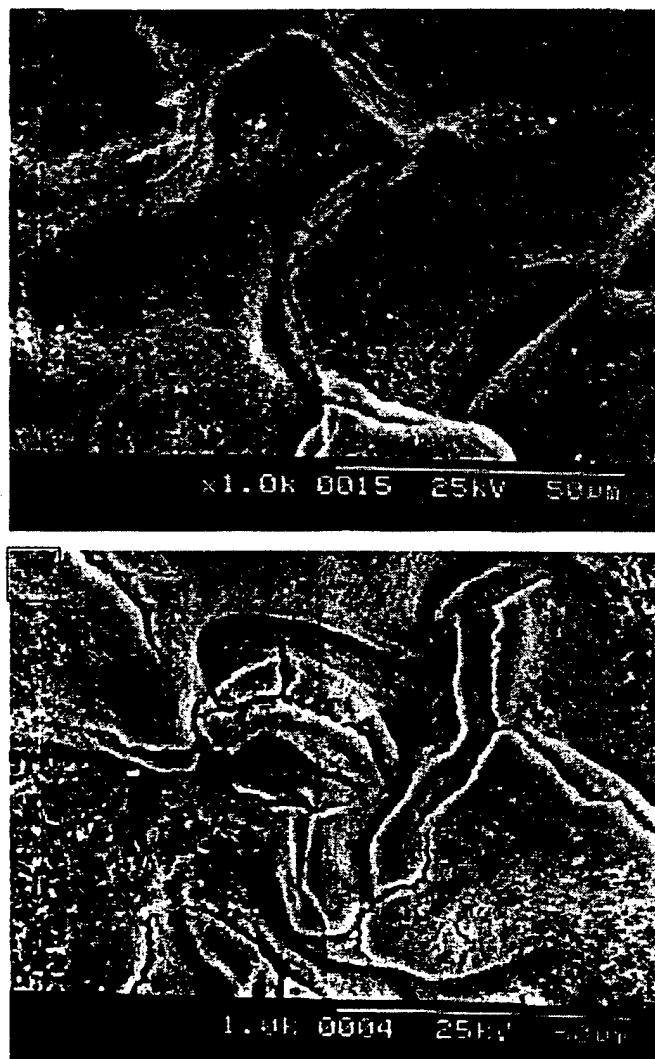
Figure 5.2 (continual) shows the top surface of type 2 specimen after 75 and 150 B cycles. Cracks increased and grew at the impression of bond coat grain boundary.

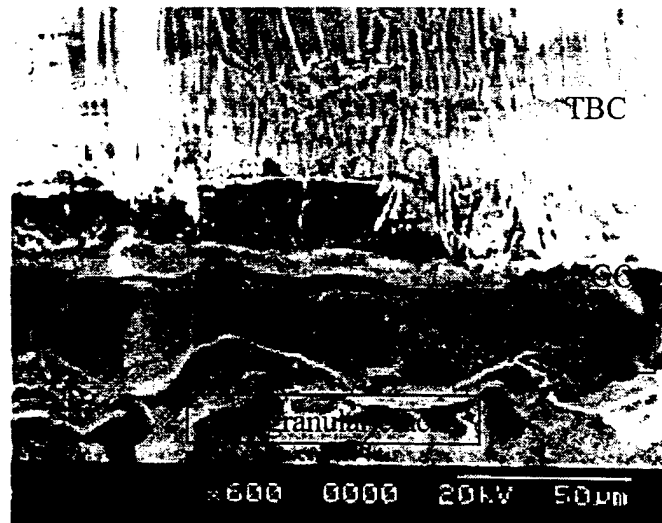
Figure 5.18 shows the cross section of a type 3 specimen after 150 hours isothermal exposure in air. TGO/bond coat separation was initiated by intergranular crack of bond coat.

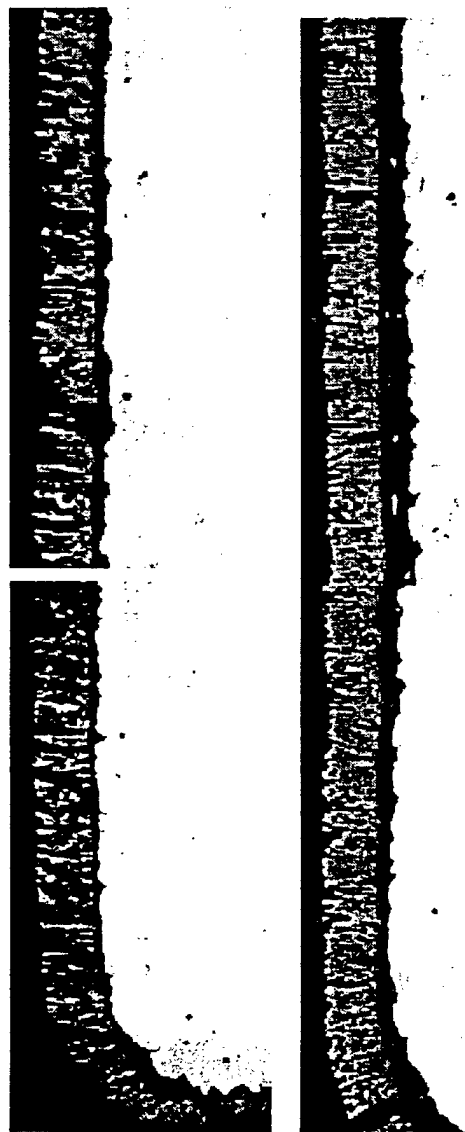
Figure 5.19 (continual) shows cross section of edge and center of TBCs after various numbers of cycles of thermal cycle B. The separation distance between TBC and bond coat increased with increased number of cycles. (110 cycles; (d) 175 cycles.

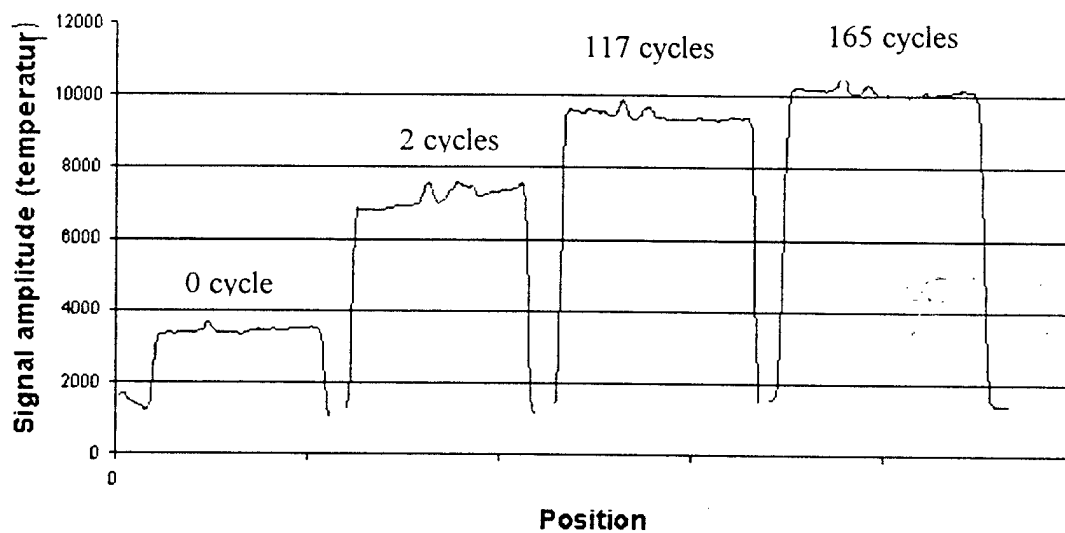
Figure 6.5 shows signal amplitude (temperature) vs position of the specimen at 0, 2, 117 and 165 cycles (sama specimen as in figure 6.4). The analysis position is shown in figure 6.4. The undulations of the curves are led by interface separation.

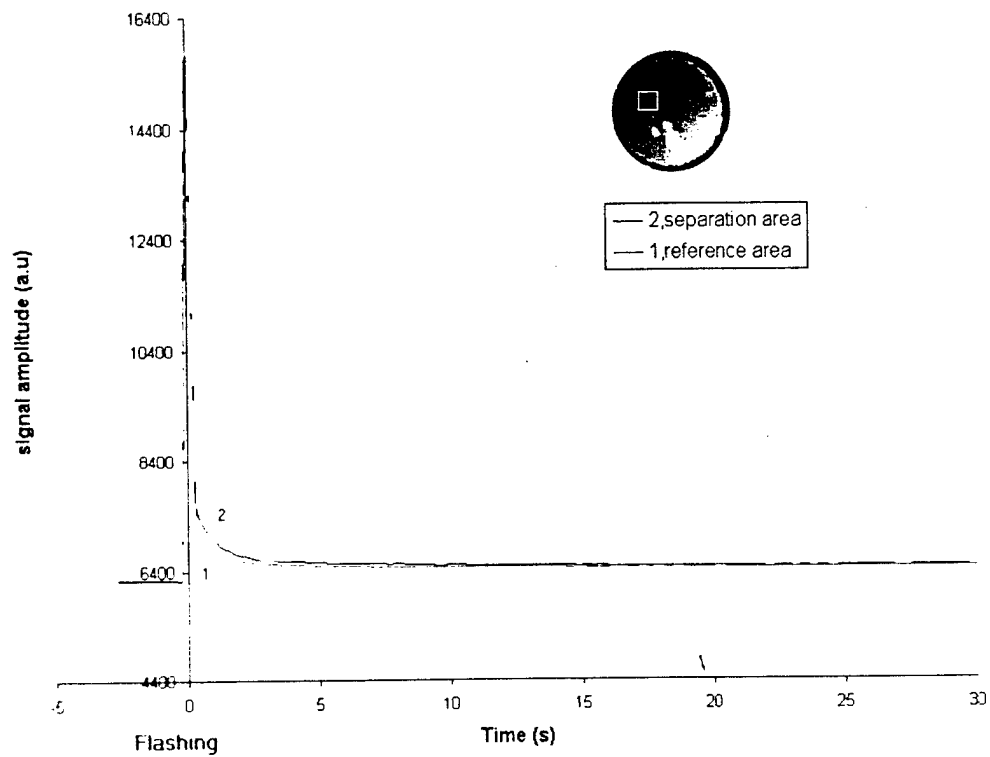
Figure 6.6 shows the surface temperature as a function of time during thermal wave imaging. Curve 1 and curve 2 represent the surface temperature of reference area and interface separation area, respectively.

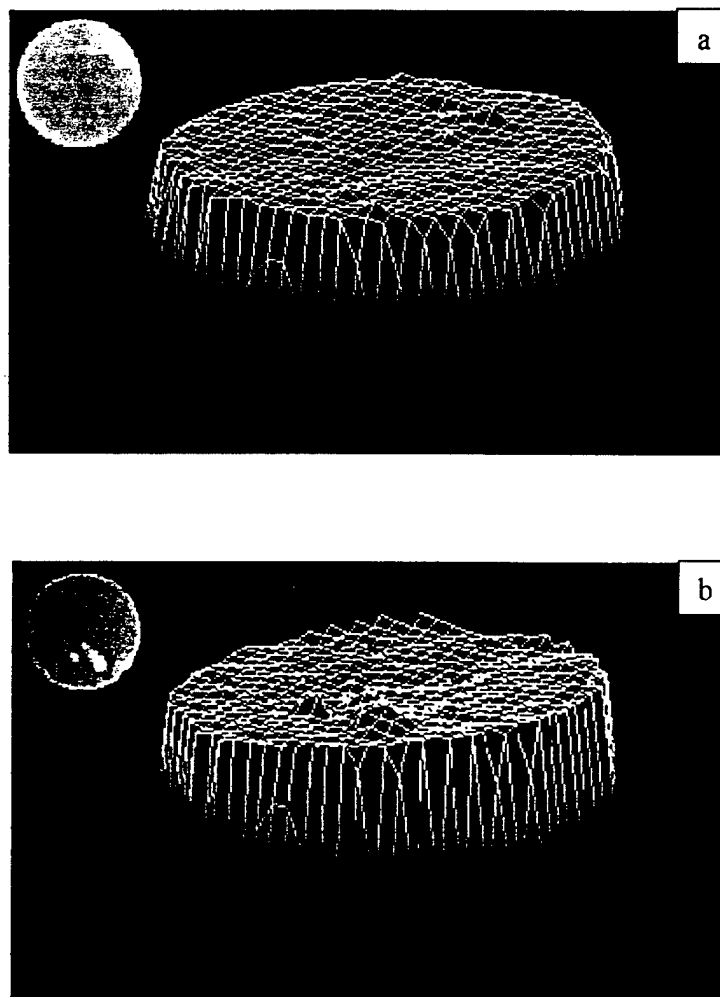
Figure 6.7 shows 3-D surface temperature distributions of the specimen with manufacturing defects at 0 cycle (a) and 2 cycles.

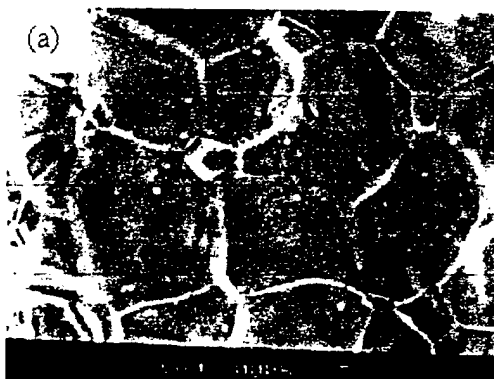
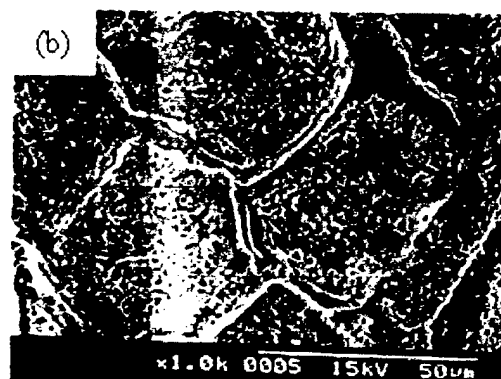
Figure 6.12 shows the damage evolution in oxide layer with increased thermal cycles (a) 0 cycle; (b) 25 cycles (c) 75 cycles; (d) 150 cycles.

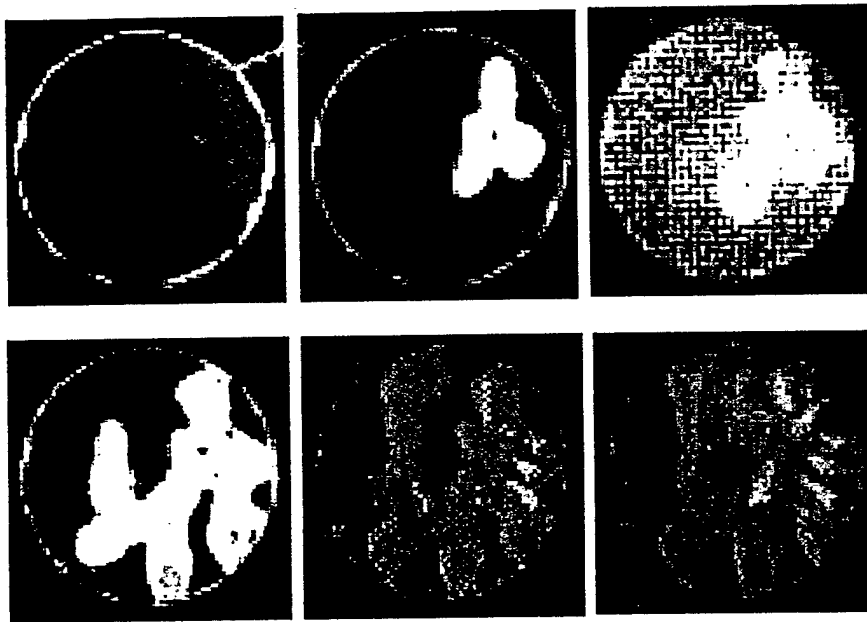
Figure 6.13 shows a processing of a separation propagating, buckling and spalling. A small separation formed during cooling. It grew and buckled at room temperature. The buckle propagated along the direction with higher curvature. Cracks formed at middle of buckle. Spalling occurred when interface crack deflected into TBC coat.

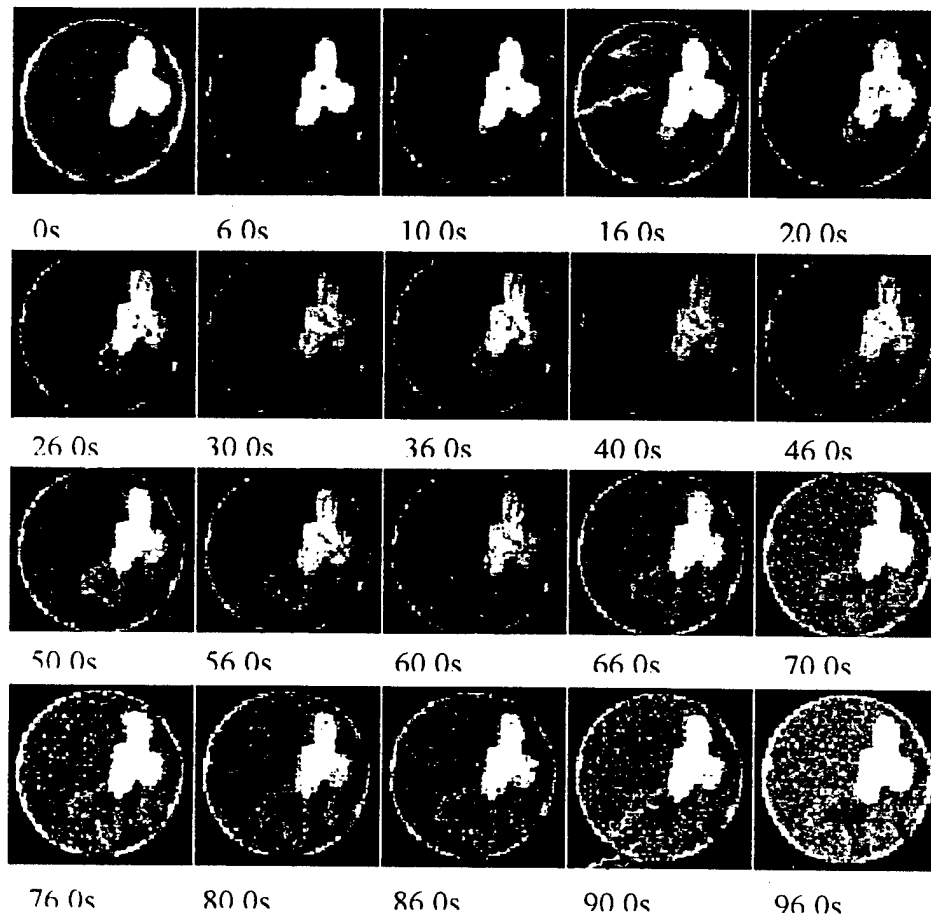
Figure 6.14 shows a series of subtraction images. The buckle propagation rate was monitored

Figure 6.15 shows the buckling propagation distance as a function of time at room temperature (image showing in figure 6.14). The two branches of the buckle were monitored

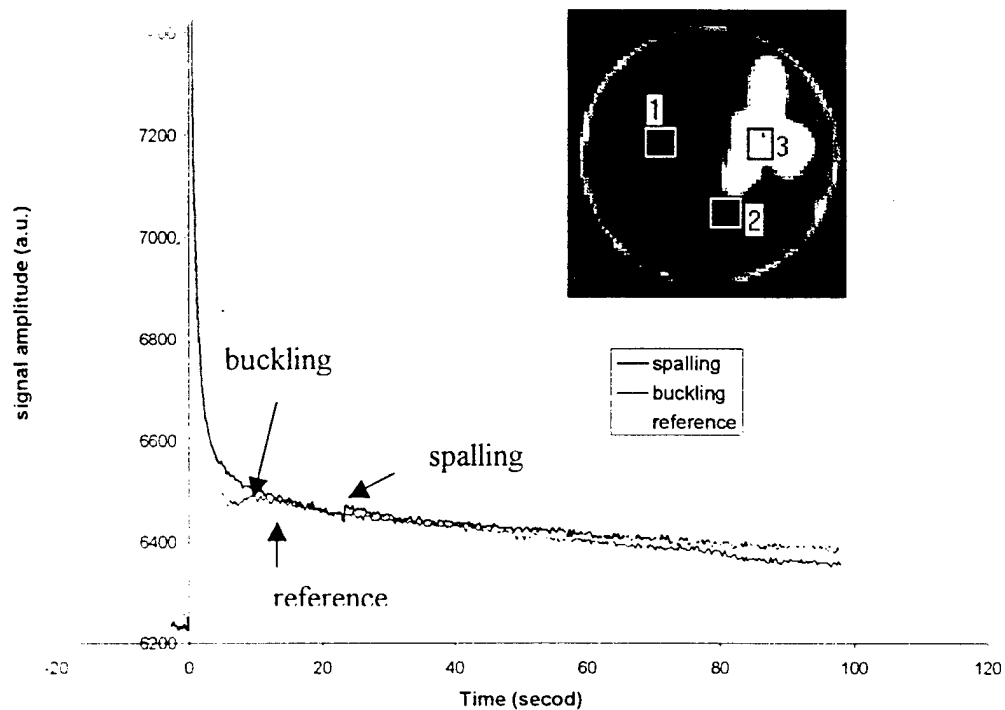
Figure 6.16 shows surface temperature feature at buckling area, spalling area and reference area, respectively. TBC buckling and spalling caused surface temperature rises.

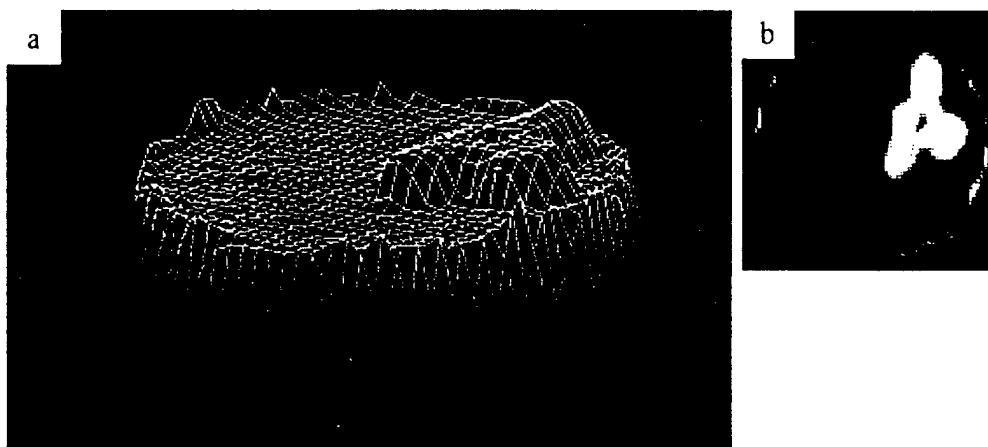
Figure 6.17 shows a 3-dimension temperature distribution profile (a) with corresponding thermal wave image (b). The buckling area had a higher surface temperature.

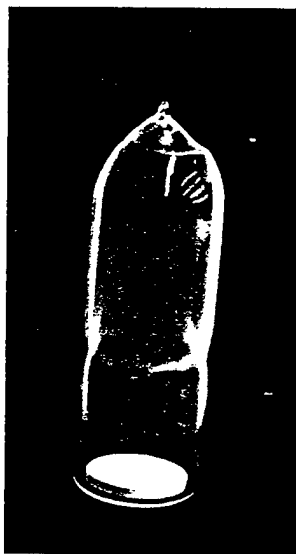
Figure 7.1 shows a TBC specimen in a vacuum quartz tube with a flat bottom.

Type 1 specimens were used to determine the lifetime of TBC and failure mode at various thermal tests. Vacuum heat treatment experiments were performed in vacuum quartz tube with a flat bottom, which kept heat from transforming to the TBCs specimen (Figure 7.1).

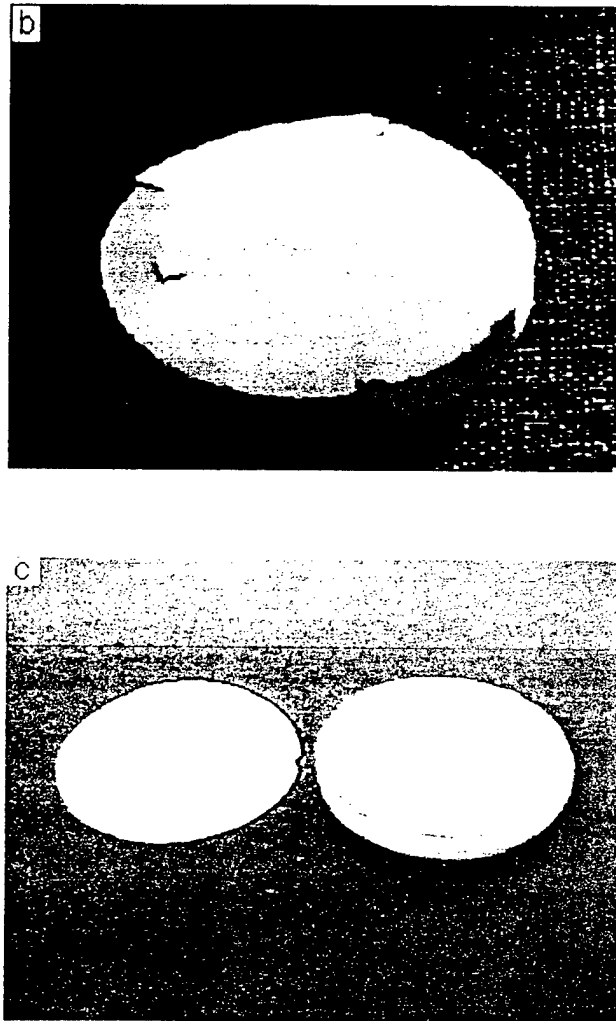
Figure 7.2 (continue) shows TBC failure mode at thermal test B (b) and thermal test C (c).

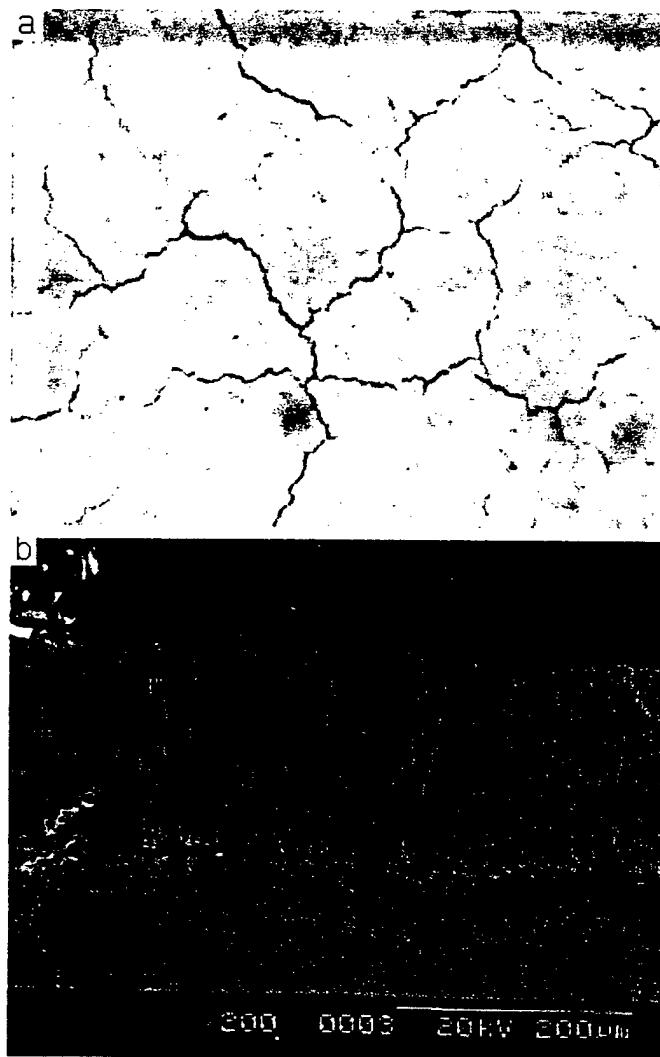
Figure 7.5 shows top surface and cross section of TBC after 50 cycles in air and 340 cycles in vacuum at thermal test B. TBC cracks always associated with grain boundaries of the bond coat.
